West Virginia Chemical Leak
Etowah, Kanawha County, West Virginia
TDD No TL01-14-01-001

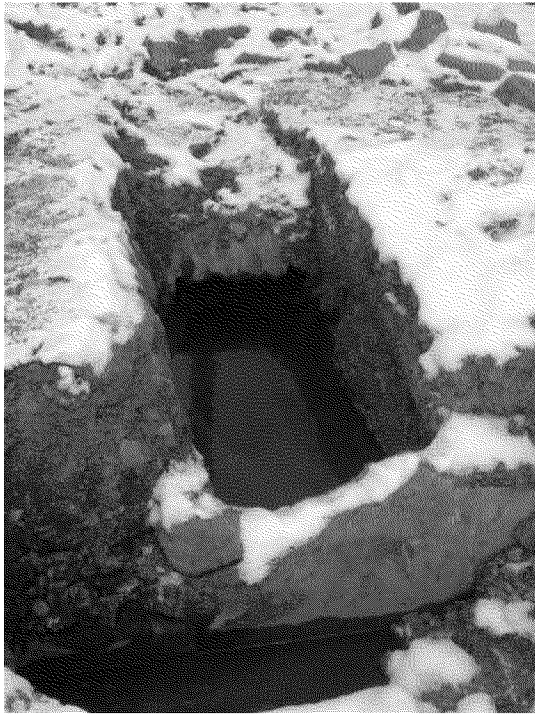
Photo No. IMG_1224; Taken on 01/23/14 at 13:51 hours by START GN. Water in sump dug at dilapidated culvert inside tank containment area.

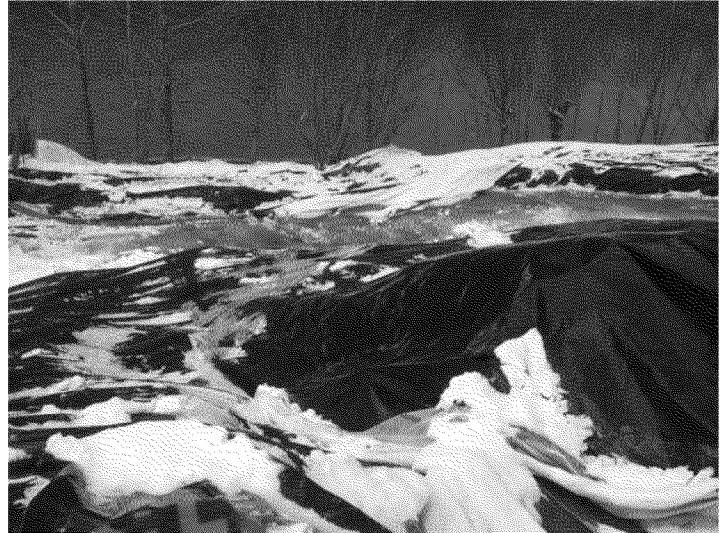
Photo No. IMG_1225; Taken on 01/23/14 at 11:42 hours by START GN. Ice covered water in collection trench
